## Millipede Barrier 2011 June Update and Final Report

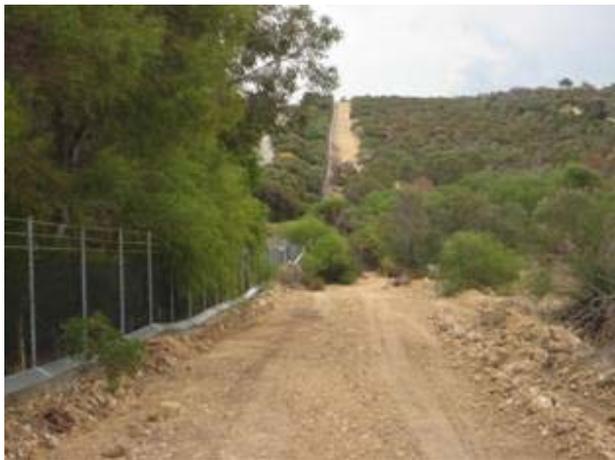
Over the past 12 months Mindarie Regional Council (MRC) has completed a 984 meter long galvanized barrier which extends along the southern fence line adjoining Kinross Residential area. Also 20 water light traps were placed along this barrier to capture millipedes moving up and down this area.

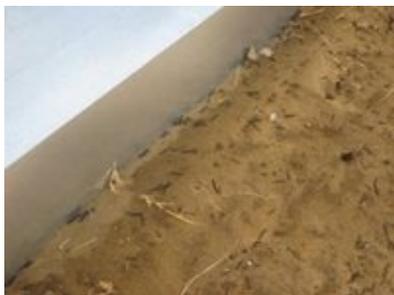
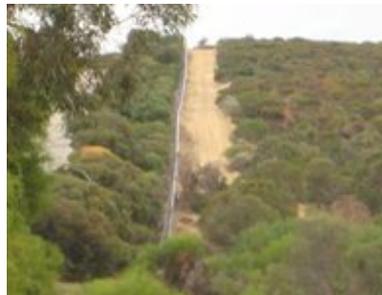
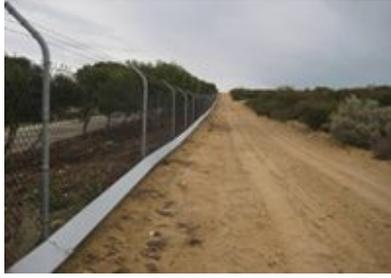
The Millipede barrier was installed in three stages, with the first stage some 200 meters being installed in July 2010 as a trial. During the winter months of 2010, periodic inspections of the barrier and adjoining streets to the southern fence line were carried out after significant rainfall events. As we all know, winter 2010 was very dry and these events were far and few between. However the millipede barrier showed to be effective in reducing the number of millipedes crossing over the boundary where it had been installed. This enabled stage two and three to be installed with confidence knowing that the barrier would hold back the millipedes from marching into Kinross. These stages were completed by March 2011.

Firstly each post along the 984 meter fence was a different distance from each other therefore, each post was measured and coded. This allowed for easy installation when the specific lengths were delivered and matched with the code. Dirt along the fence was pushed aside allowing each galvanized length (around 4m) to be tec-screwed onto the post. The tilted portion of the barriers not attached to the post was tec-screwed onto the next code piece of galvanized sheeting. Once the sheeting was attached to the posts, dirt was pushed back making sure that no holes were under the barrier. As each stage was completed, dirt holes were checked and sealant was used to infill caps in the sheeting joins.
