INFORMATION BULLETIN

**Issue No. 47
February 2019**

RRF UPDATE REPORT

BioVision 2020 Pty Ltd Advanced Resource Recovery Facility 12-month Dieback Sampling

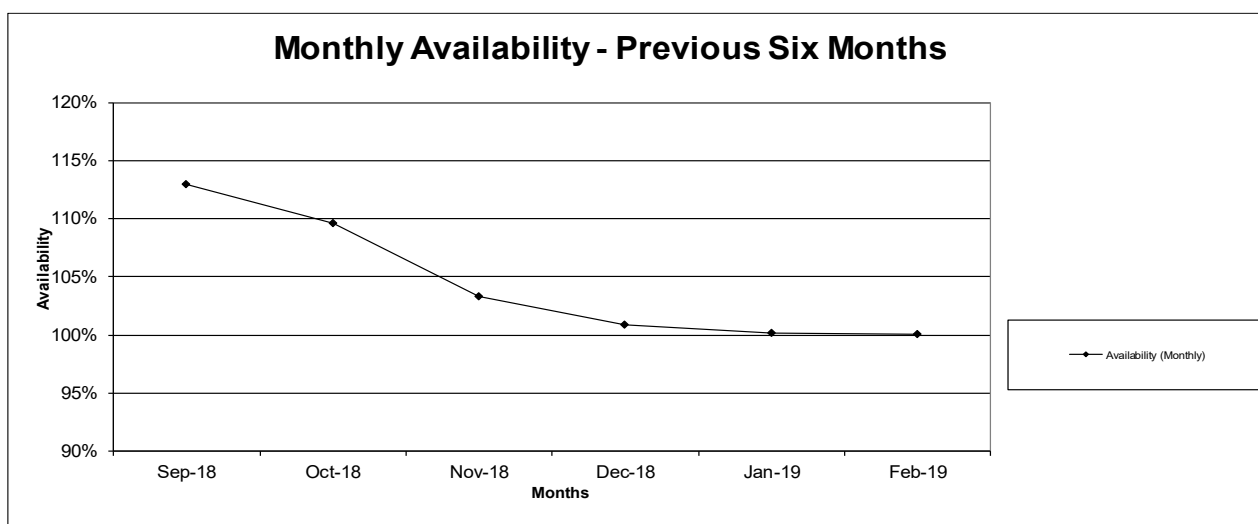
Graph No. 3 – Monthly Availability – Previous Six Months

The RRF is operating as anticipated in the RRFA, with average availability of 107.25% over the past 12 months.

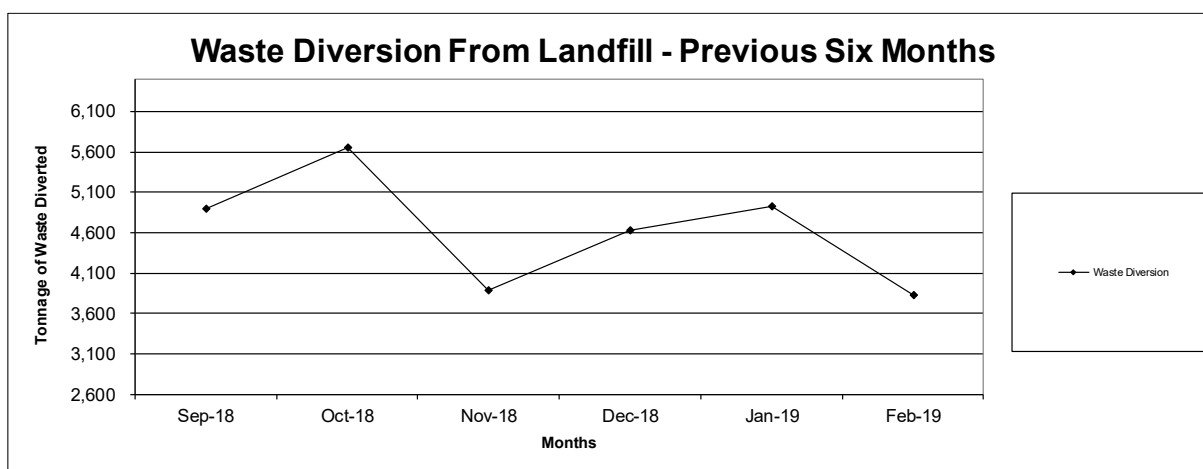
**Graph No. 5 – Waste Diversion from Landfill – Previous Six Months**

The average waste diversion for the past six months (September 2018 to February 2019) has been 53.6%.

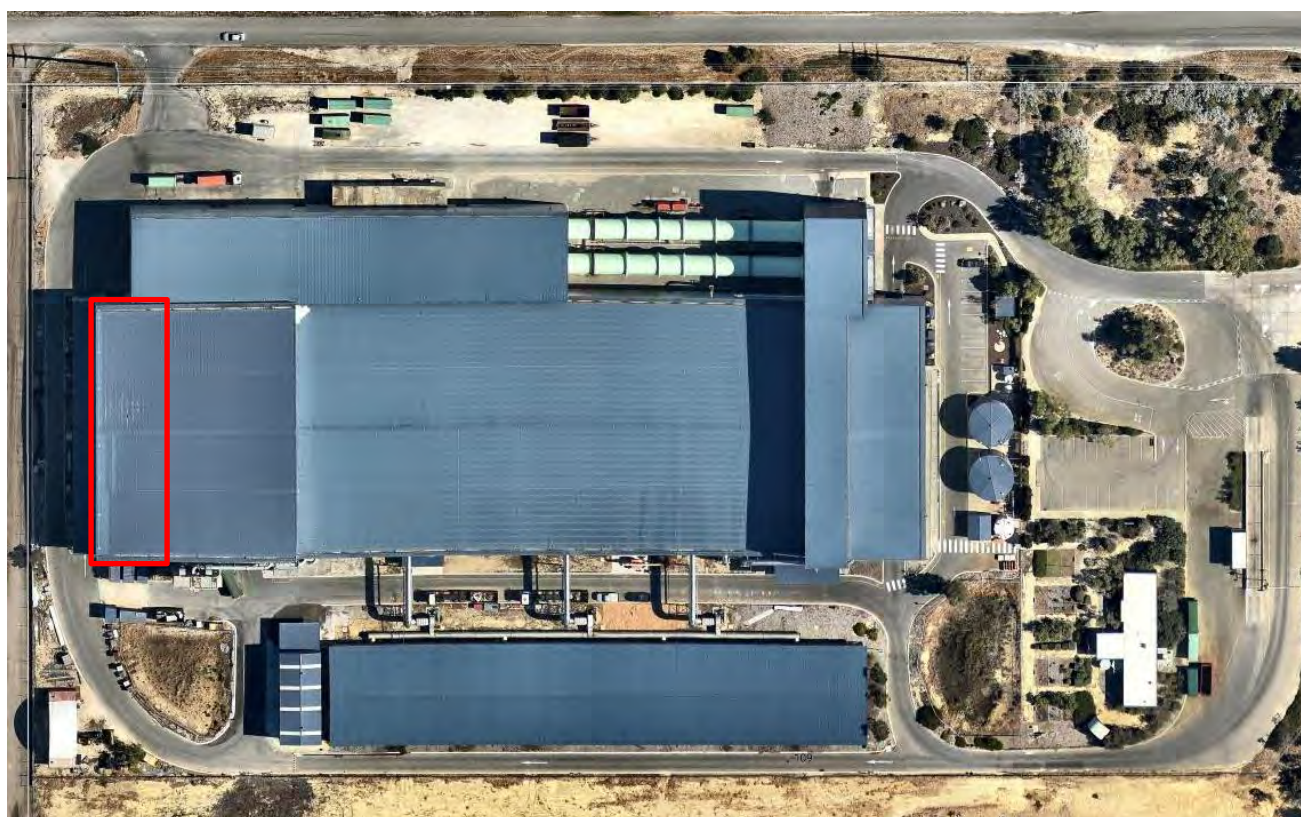
Sampling was undertaken twice a month from the BioVision ARRF soil conditioner holding zone (Figure 1) for the duration of 2018; 24 samples were collected in total with each sample being approximately 500 grams. The sampling was undertaken from different times and locations within the holding zone during each event, and the GPS location of the sample location recorded. A sampling sheet was maintained detailing the date, time, and characteristic of the product at the time of sampling.

Figure 1: Sample location at BioVision ARRF Neerabup facility outlined in red

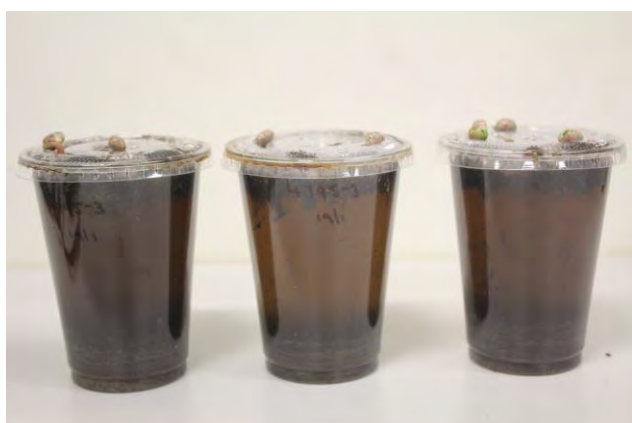
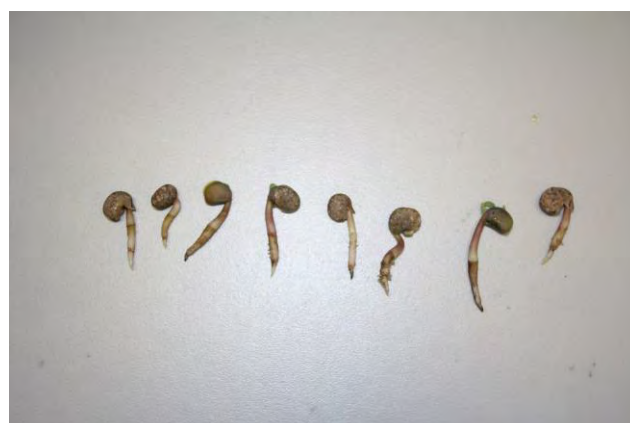
Lupin baits after 3 days

Rotting lupins after 3 days

Stunted growth of lupin baits after 3 days

No pathogens were detected, but media appeared to have properties that may be adverse to plant growth, causing a phytotoxic reaction to the lupins. This may have been caused by a low oxygen environment or some other property of the media, e.g. pH, EC nutrient toxicity, etc.

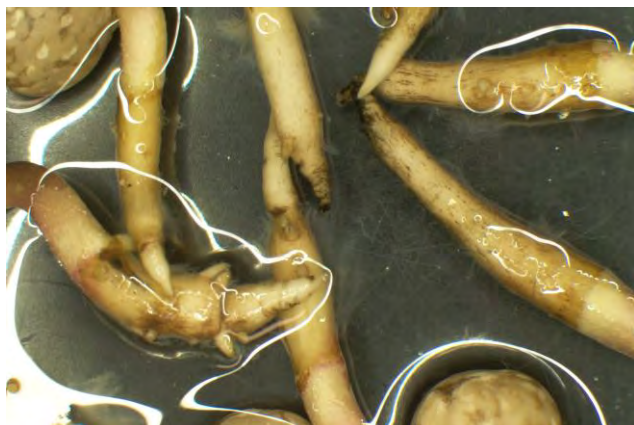
Close up of cracked and rotting lupins

Stunted growth of lupin baits after 3 days

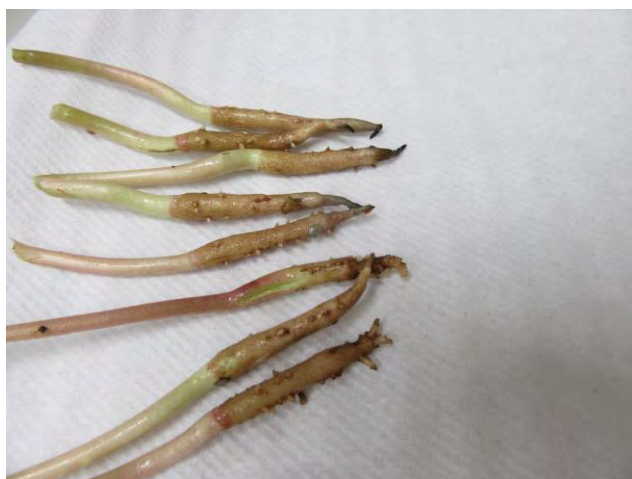
Test Name	Results	Comments
Lab Observations		
Lupin Baiting	Negative	Lupins showed cracking and slight rotting of the root tip. Further testing of the lupins indicated that Phytophthora was not present.

Lupins at 5 days, necrosis at root tip

Phytophthora was not detected from the growing media. However, some property of the media did cause cracking and slight rot of the lupins. It is not known what factor might have been responsible.

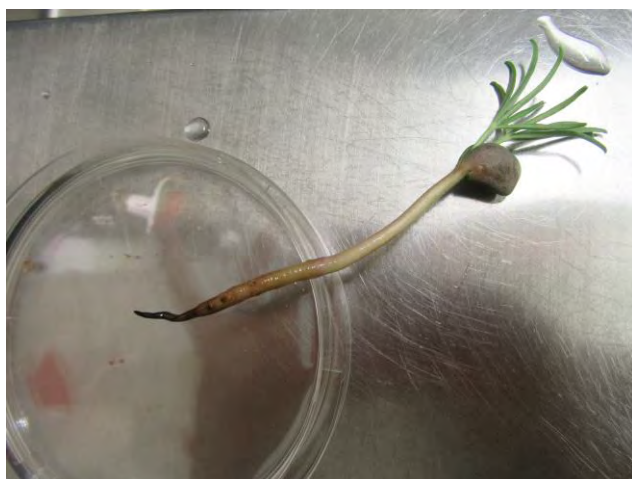
Necrosis on lupins (not Phytophthora)

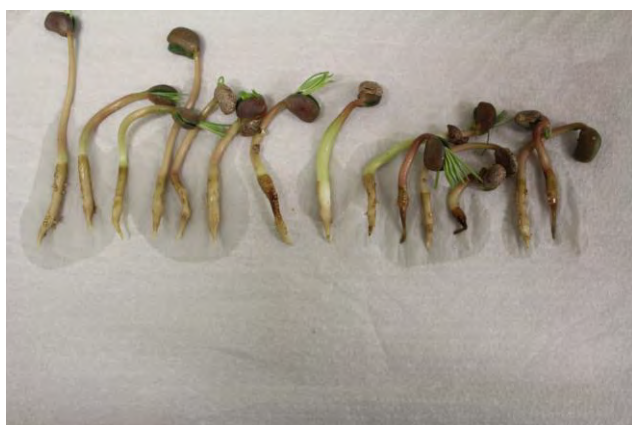
Unhealthy lupin after a baiting within the media

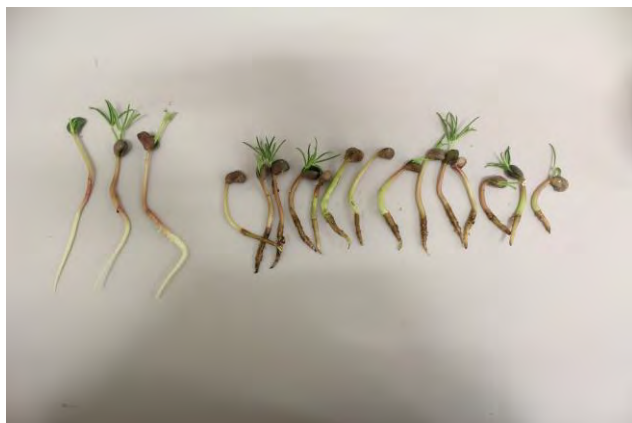
Healthy lupin compared to unhealthy lupin after a baiting within the BioVision media

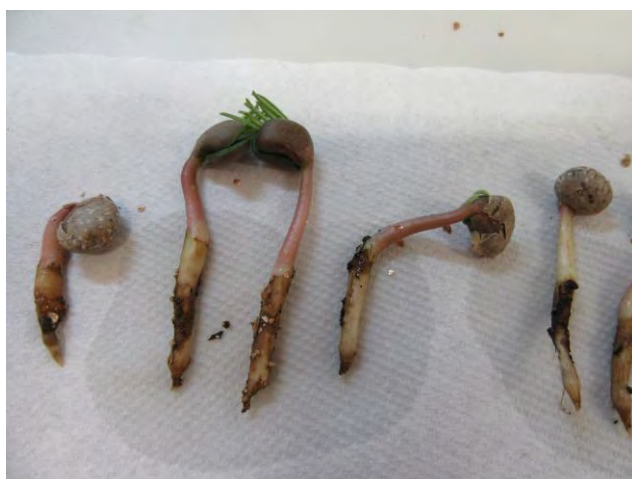
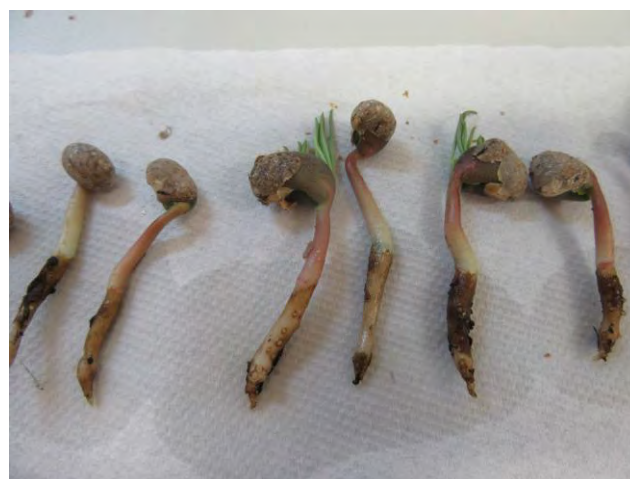
Stunted lupins from baiting

No pathogen was detected, however some non-pathogenic factor appeared to have affected the roots of lupins.

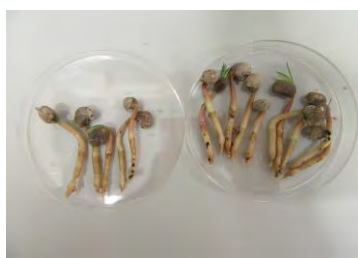
Unhealthy lupins after baiting

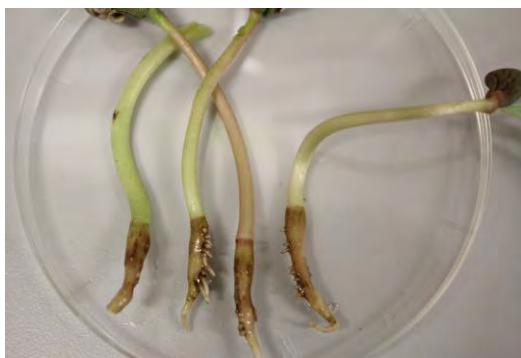
Unhealthy lupins after baiting

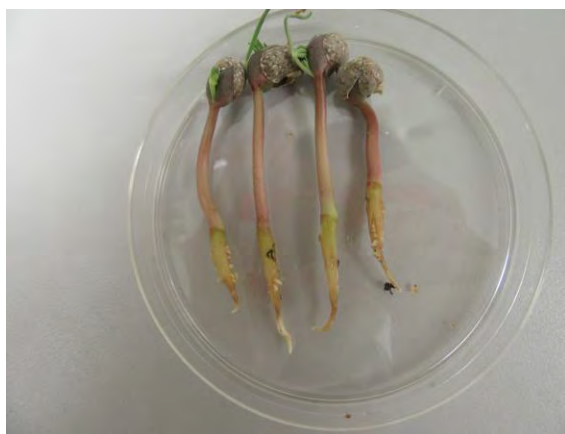
Test Name	Results	Comments
Phytophthora baiting	Negative	<i>Phytophthora</i> sp. was not detected from growing media. However lupin roots appeared decayed.

Unhealthy lupins after baiting
